Cape Lookout National Seashore
GASKILL - GUTHRIE HOUSE

HISTORIC STRUCTURE REPORT

2002
Historic Structure Report
Gaskill- Guthrie House
Cape Lookout Village
CAPE LOOKOUT NATIONAL SEASHORE
Harker's Island, NC
LCS#: 272049

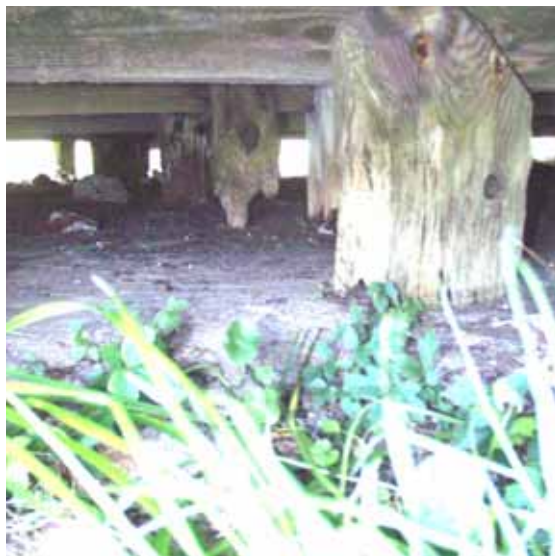
Figure 2 View of rotted wooden piers that formerly supported floor joists at mid-span. (NPS-SERO-CRS, 2002)

The wood frame of the main body of the house is within inches of the ground, with the sills set on a series of wooden piers, 8" - 12" in diameter, sunk to some indeterminate depth into the ground. Most are, at best, in fair condition, and concrete block have been inserted at some locations to provide additional support.

- Replace all piers, replicating size and placement of originals.

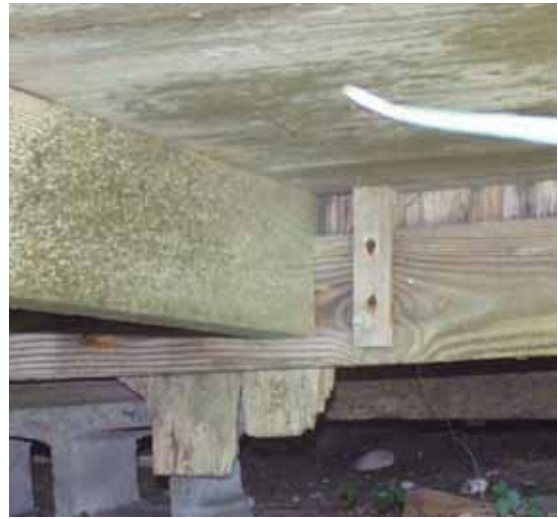
Figure 3 View of front sill of house and typical joist and stud connections. (NPS-SERO-CRS, 2002)

siding. To minimize storm damage, the builder notched the studs over the perimeter sills and nailed the tongues to the sills, producing a substantially stronger connection than could be had by a standard toe-nailed connection.

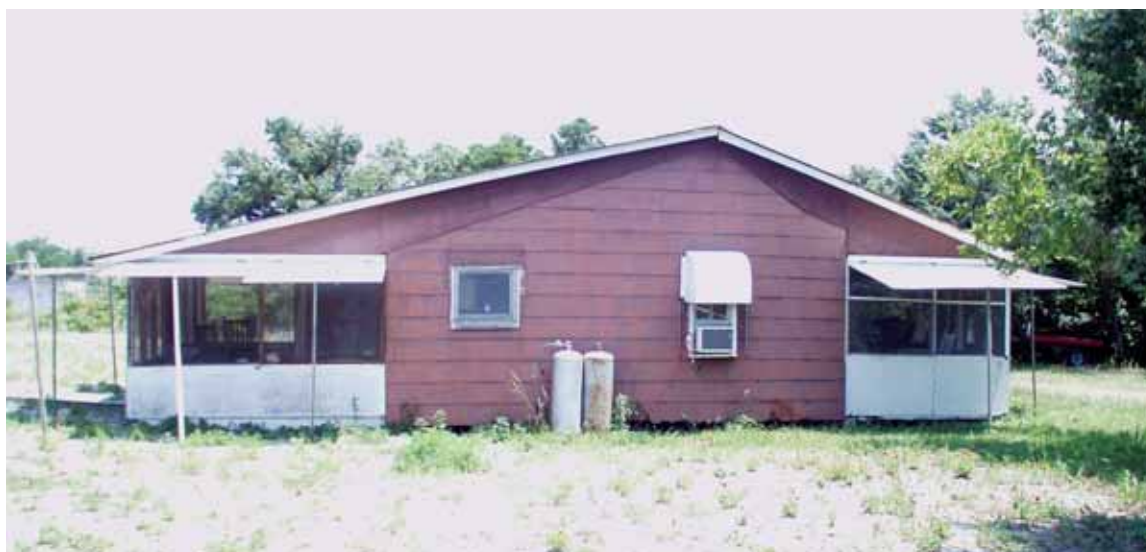
Figure 5 View of southwest side of house, showing line of original roof prior to installation of present roof after 1976. (NPS-SERO-CRS, 2002)

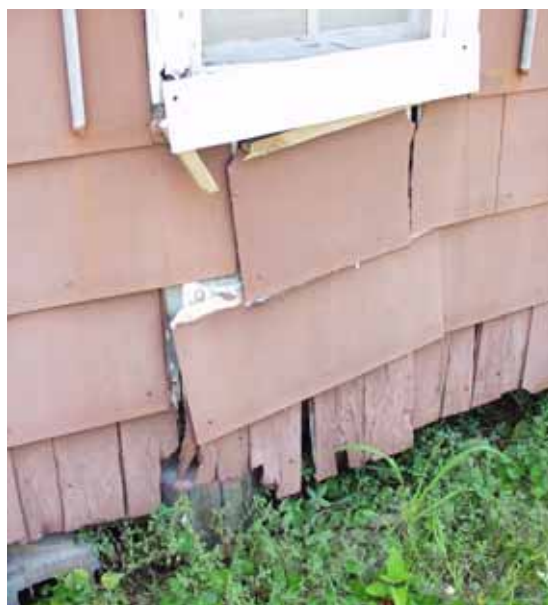
Floors: Original floor joists are generally 2" by 6- 1/2" (actual dimension), set on 32" centers. Single 2" by 6- 1/2" boards form the perimeter sills of the original house. As noted above, the mid- span supports for these joists have rotted, which has left the floor system unstable. In addition there has been severe sill damage at several locations, especially on the northeast side of the house.

Figure 6 View of damaged siding on northeast side of house, the result of major sill damage in this location. Original board siding is exposed across bottom of wall. (NPS-SERO-CRS, 2002)

- Reduce span of joists and rafters by adding intermediate members.
- Repair termite- damaged and/or rotted sills and other framing elements as necessary.
- Reconstruct original porches.
- Restore original roof line.

- Remove asbestos siding, reusing or stockpiling the shingles.
- Repair and preserve underlying tongue- and- groove siding.

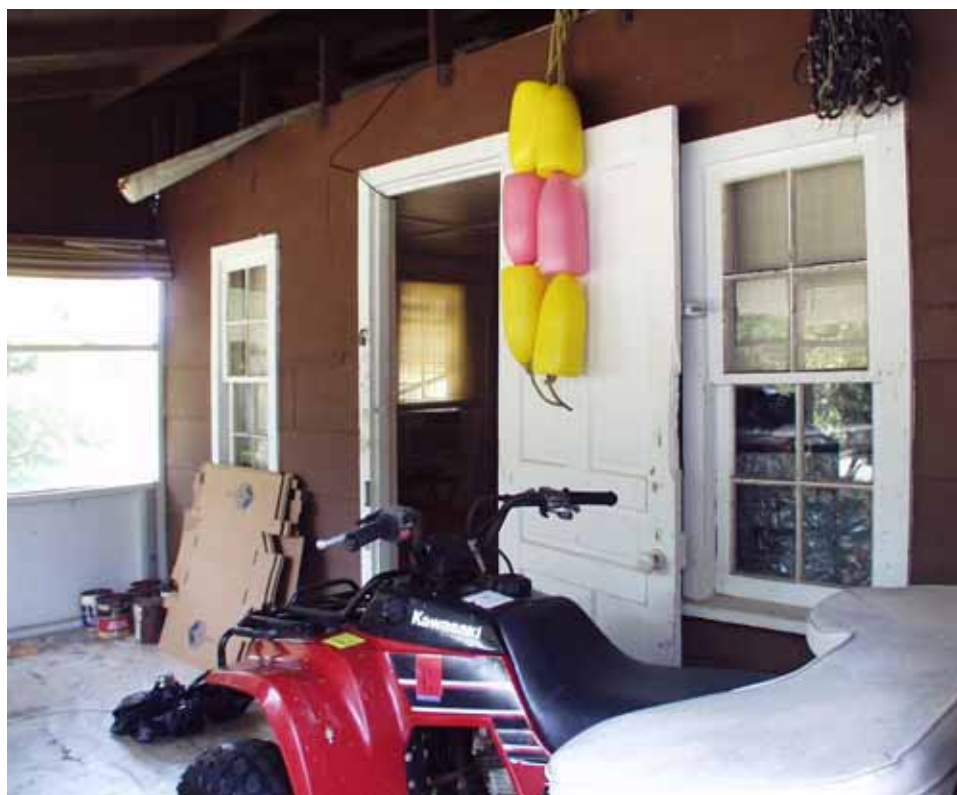
W- 1: Double- hung, four- over- four, wooden sash, 1'- 7" by 3'- 8", similar to the original windows at the Bryant House. Typical exterior casing, 2- 3/4" wide, no drip cap. A large, rounded, metal awning, added after 1976, covers the upper half of the window.

Figure 7 View of front porch with original windows and door. (NPS- SERO- CRS,2002)

- Repair and preserve existing windows.
- Remove metal awnings.
